Manhole Inspection Summary

Manhole # S39A2_017MH

Insp Date: **12/26/07 10:15 AM**

Location Address: **3801 5th St**

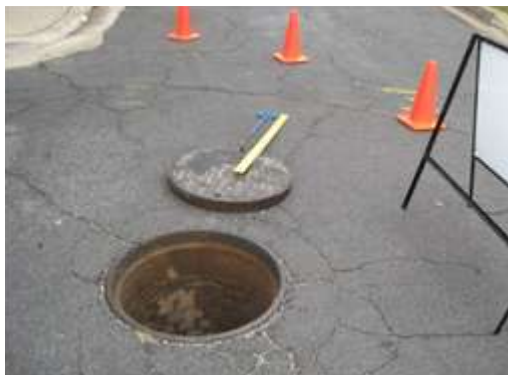
Location View

3807 5th St

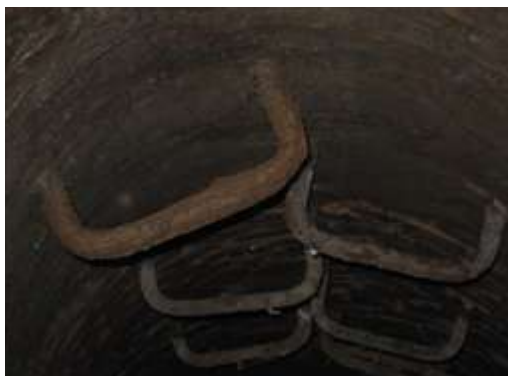
Count: **6** Missing: **1** ☒ **Corroded**

steps

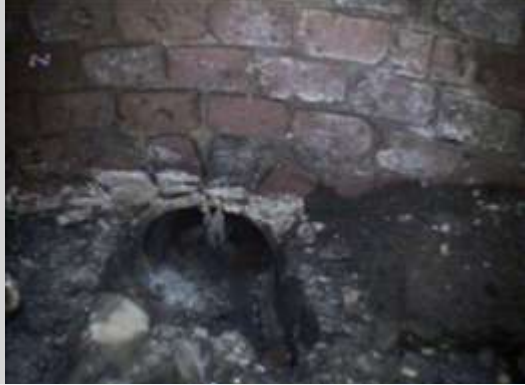
12 O'Clock Outflow

8 in. Circular Gravity Sewer
Pipe Out @ 12 O'Clock

Pipe Height: **9.6** (in.) Rod and Bar (Angled)
Pipe Material: **Clay** ☐ Pipe Lined
Invert Depth: **12.42** (ft.) Flow Characteristics: **Fast**
Deposits: ☐ None ☐ Mud ☐ Sludge ☒ **Debris** ☐ Grease
Silt Depth: **2** (in.) Deposits Extent: **Medium**
Infiltration: **None** Pipe Seal Cond: **Sound**

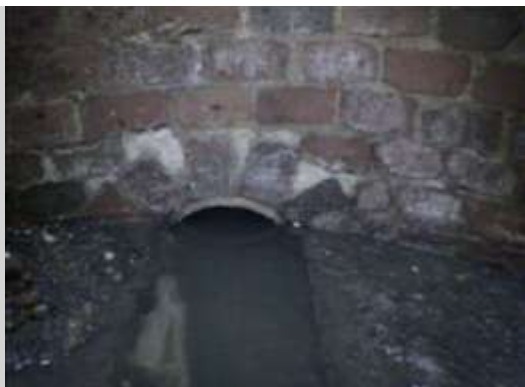
3 O'Clock Inflow

8 in. Circular Gravity Sewer
Pipe In @ 3 O'Clock

Pipe Height: **9.6** (in.) Rod and Bar (Angled)
Pipe Material: **Clay** ☐ Pipe Lined
Invert Depth: **12.26** (ft.) Flow Characteristics: **Slow**
Deposits: ☒ None ☐ Mud ☐ Sludge ☐ Debris ☐ Grease
Silt Depth: (in.) Deposits Extent:
Infiltration: **None** Pipe Seal Cond: **Sound**

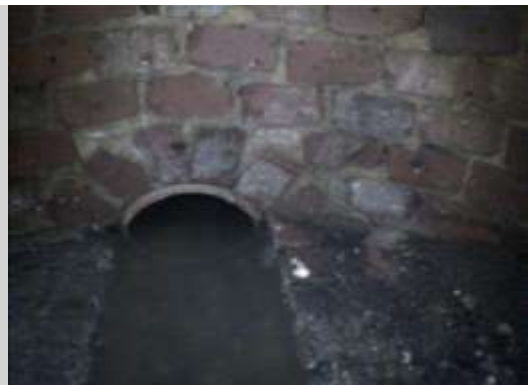
6 O'Clock Inflow

8 in. Circular Gravity Sewer

Pipe In @ 6 O'Clock

Invert Depth: **12.16** (ft.) Flow Characteristics: **Slow**

Deposits: ☒ None ☐ Mud ☐ Sludge ☐ Debris ☐ Grease

Infiltration: **None** Pipe Seal Cond: **Sound**
